Tragedy at Lake Garda

By Charles C. Roberts, Jr., MVPA #9732

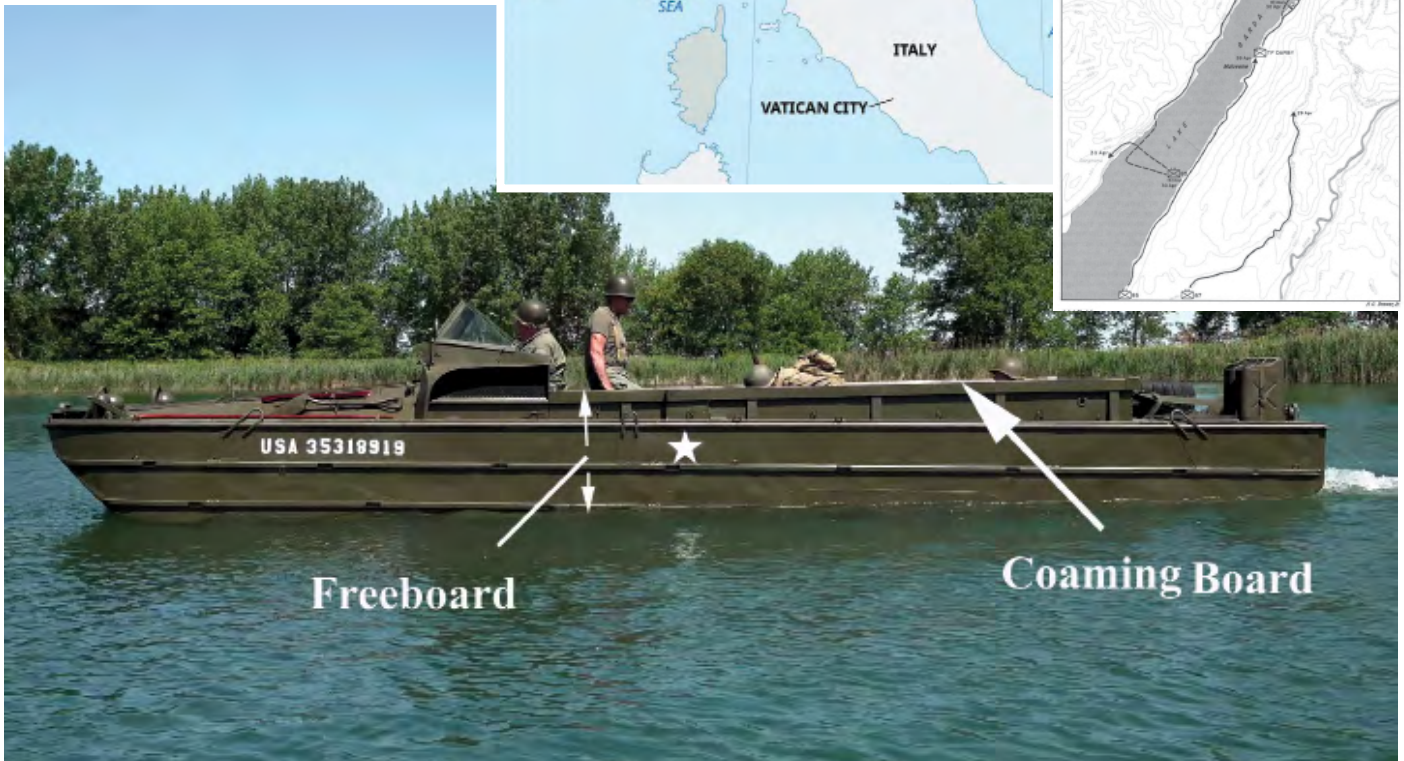
Often referred to as a "Duck," the GMC-manufactured DUKW combined the versatility of the 2-1/2-ton 6x6 cargo truck while also being amphibious. This view of an unloaded, late-model DUKW shows the coaming board, an upward extension of the hull meant to reduce the chance of water entry. "Freeboard" is the distance from the top of the coaming board to the water line. In 1945, a DUKW carrying members of the 10th Mountain Division entered the waters of Lake Garda in Italy. Overloaded, the freeboard was less than 1 foot. The results were disastrous — 25 U.S. soldiers lost their lives. *Author photo*

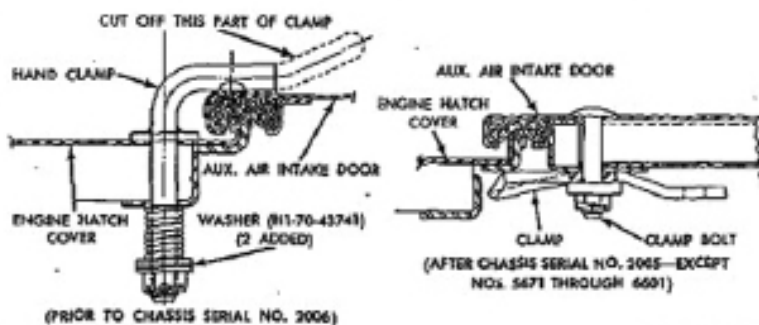
Figure 201—Auxiliary Air Intake Door Permanently Closed

f. **Auxiliary Air Intake Door (fig. 201).** Additional cooling advantage by use of auxiliary air intake is offset by danger of stalling engine by shipping water through door. Therefore, it is recommended that door be permanently closed on vehicles prior to chassis serial No. 7136 (except Nos. 5671 through 6601) as follows:

This illustration from TM 9-802, 23 February 1945, demonstrated how to permanently seal the air scoop on early production vehicles.

air intake door operating mechanism including screen. Do not remove latches.

(2) Cover hole in upper toeboard with any suitable metal plate, attaching plate with screws. Remove "Auxiliary Cooling Air Intake" instruction plate from vehicle.

(3) Inspect air scoop door seal (G501-03-82791) and make any necessary repairs or replacements to insure a watertight seal.

(4) At under side of engine hatch cover, remove nuts, cotter pins from latch bolts. With latch in locked position, install $\frac{3}{8}$ -inch lock washer, install nut and cotter pin, and tighten securely to permanently close door. On vehicles with hand clamps (prior to chassis serial No. 2006), remove nuts. Install two additional $\frac{3}{8}$ -inch flat washers (HI-70-4371) on each bolt, then install nut. Make sure clamps are in proper position to lock hatch cover, then firmly tighten nuts to fully compress springs and secure with cotter pins. On vehicles prior to chassis serial No. 2006, cut off ends of clamps. Tack-weld clamps to door, using shielded arc. Avoid heating door sufficiently to burn seal.

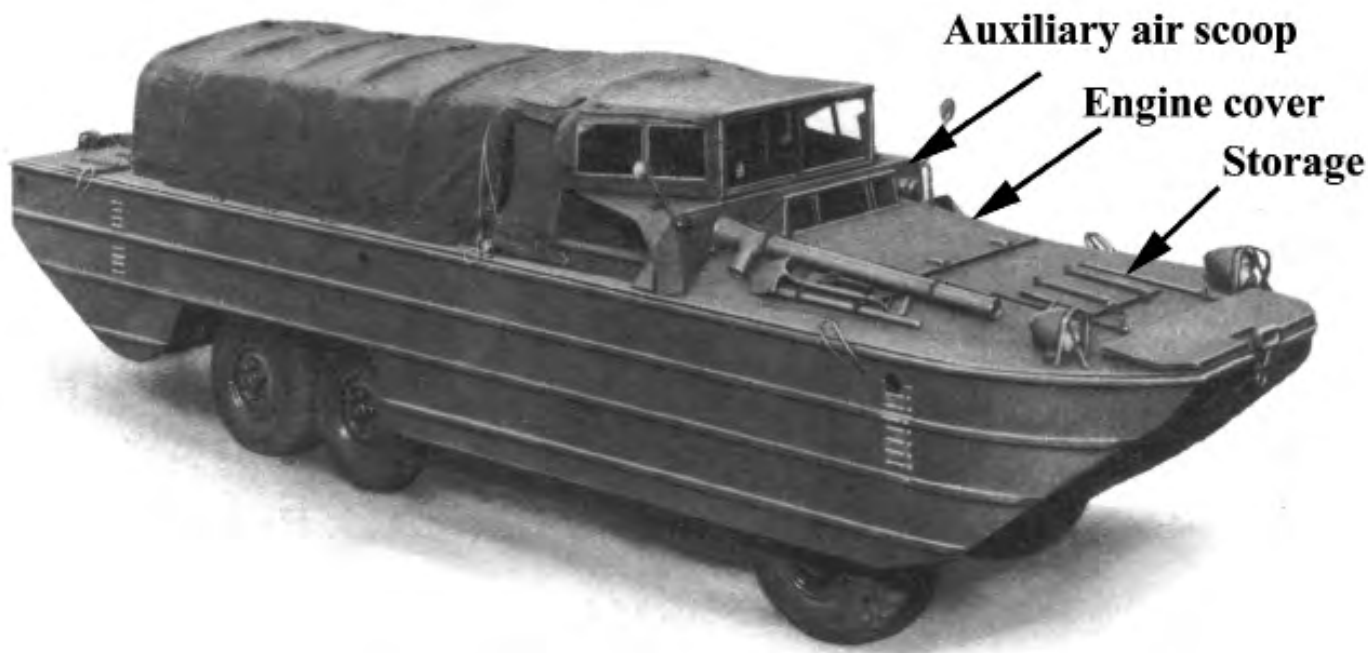
Right front view of an early model DUKW showing the auxiliary air scoop air intake, engine cover, and storage hatch. According to early technical manuals, closing the door on the air scoop is required during water operation. The air scoop air intake was eliminated from vehicles after 1943 because, when left open, wave action would swamp the bow; water would enter the engine compartment, and could stall the engine. *TM 9-2800*

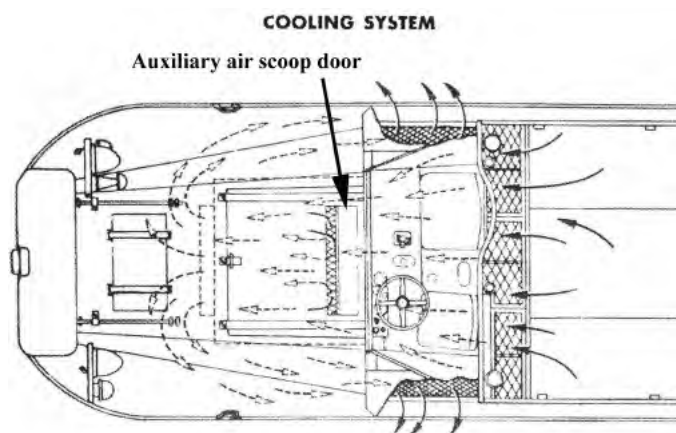
The cooling system on a DUKW is a pusher system where air is pushed forward through the radiator rather than drawn through the radiator, as in conventional land vehicles. The auxiliary air scoop allows cooling air to go directly into the engine compartment, which helps cool, but is a hazard when left open in heavy seas, as mentioned in *TM 9-802*, 1 September 1943

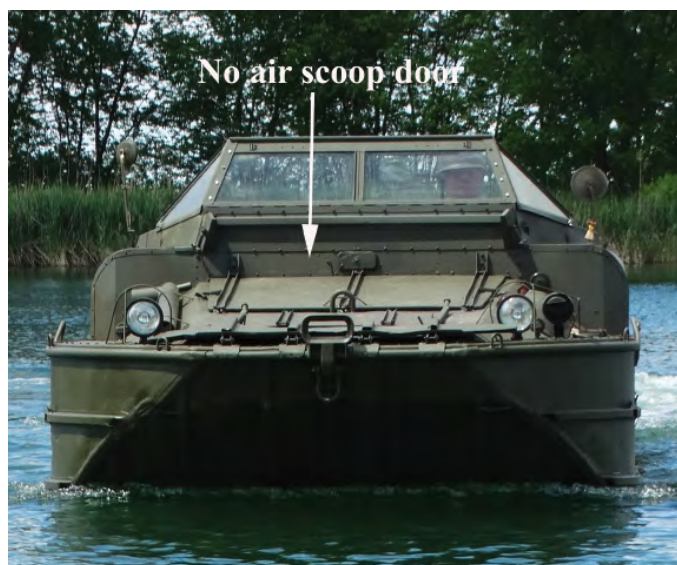
As seen in this photo of a late 1945-vintage DUKW, the auxiliary air intake (air scoop) doors were removed from the design. *Author photo*

The Army instituted a design change in 1943, that eliminated the auxiliary air intake door on later models. In addition, it advised permanently sealing the air intake

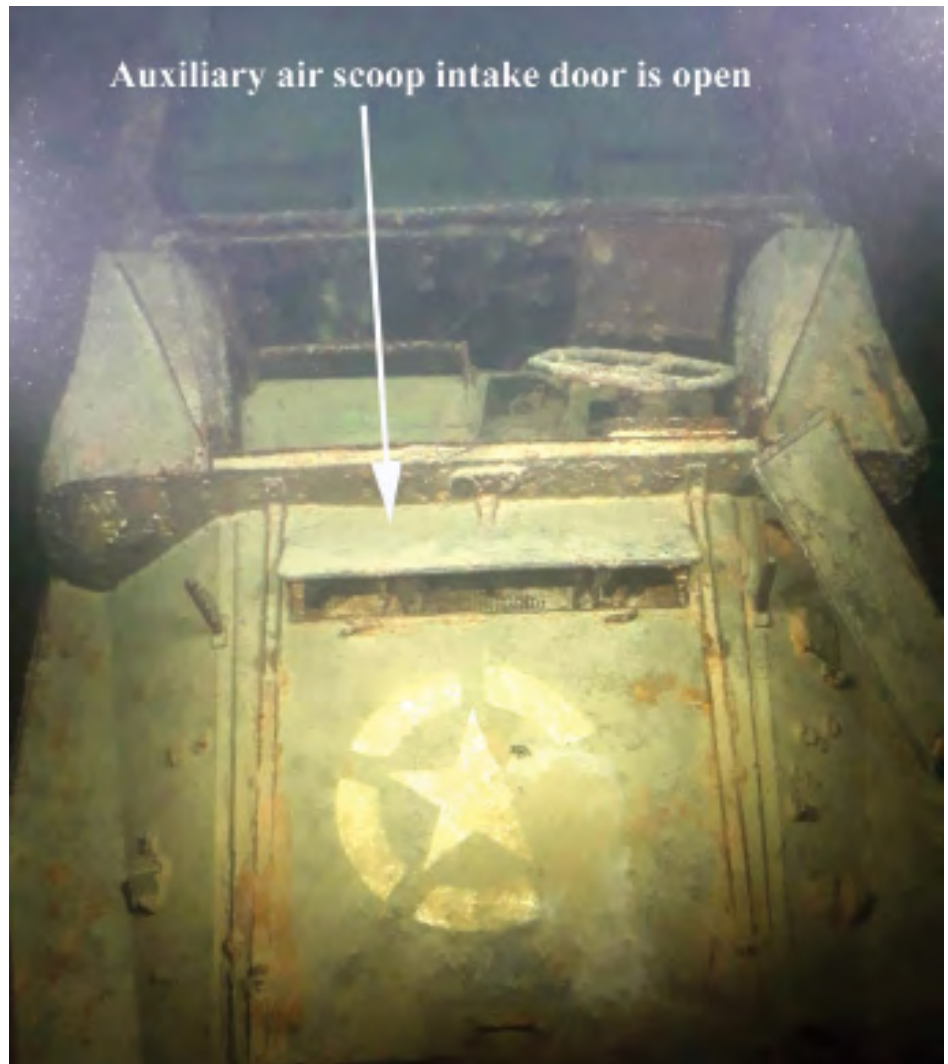
There was a design flaw in the early DUKWs, however. The air intake was located where water could easily enter the engine compartment and stall the engine. The auxiliary air intake door was designed to help get more air

into the engine compartment and enhance airflow through the inlet openings in the engine compartment. The problem with the auxiliary air intake scoop was that it easily ingested water in heavy seas, causing the engine to quit and, in some cases, the DUKW to sink.

The bow view of the ill-fated DUKW at the bottom of Lake Garda shows the auxiliary air scoop door open. This would have allowed water to enter the engine compartment directly, probably shorting out the ignition system and causing the engine to stop. The air scoop door should have been closed. *ProMare photo*

doors on older models. According to *TM 9-802*, issued on 23 February 1945, the Quartermaster Corps was supposed to seal all auxiliary air intake hatches shut. It is not known why this had not been accomplished on the ill-fated DUKW.

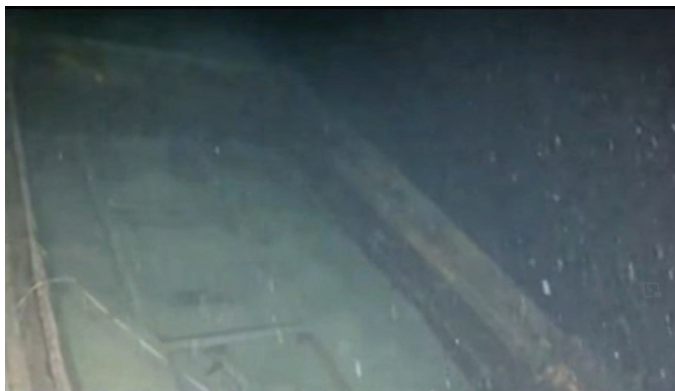
This view of the ill-fated DUKW at the bottom of Lake Garda shows the empty cargo compartment. The plywood floor boards have floated away, showing the support framing and the bottom of the hull. According to the lone survivor, Corporal Thomas Hough, the soldiers threw everything overboard. This photo shows that nothing remains in the cargo compartment. Because of the running gear and suspension system, a DUKW is very bottom-heavy. It sank like a submarine submerging — not rolling over — and settled to the bottom of the lake, upright. *ProMare photo*

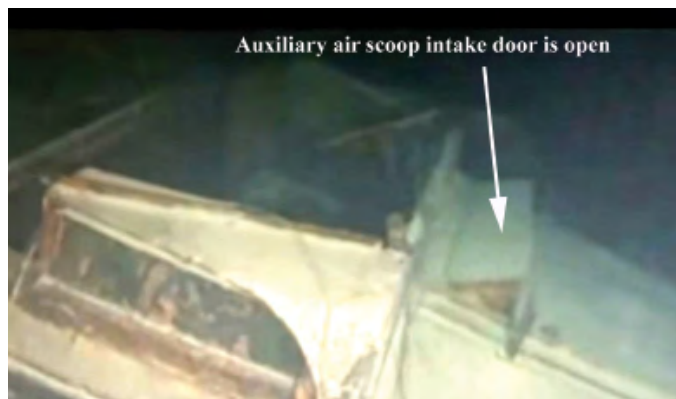
PFC Nicholas Del Grosso, the DUKW’s driver, had become worried that the engine compartment had flooded due to Lake Garda’s rough waters. He was probably correct. A starboard side view of the ill-fated DUKW shows the auxiliary air scoop door open — this would have allowed water to enter the engine compartment, probably shorting out the ignition system, and causing the engine to stop. It should have been closed. *ProMare photo*

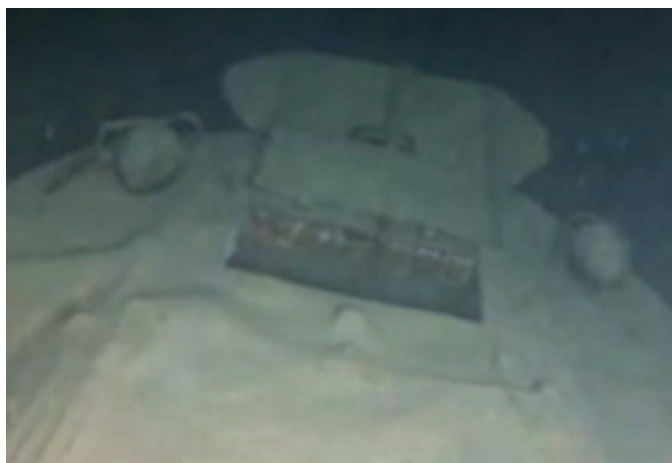
A bow view of the ill-fated DUKW shows the bow storage hatch open. According to Cpl. Hough, PFC Del Grosso opened this hatch to get tools to work on the engine. The open bow storage hatch allowed more water to enter the engine compartment and aggravated the flooding, causing the bow to fill with water first. *ProMare photo*
